N08709/01-AB ABL:KLW
30 November 2005

Coal River Working Party
C/- School of Liberal Arts
University of Newcastle
University Drive
CALLAGHAN NSW 2308

**RE: INVESTIGATION OF CONVICT COAL MINE WORKINGS
BENEATH COLLIERS' POINT, NEWCASTLE EAST
RESULTS OF DRILLING INVESTIGATION**

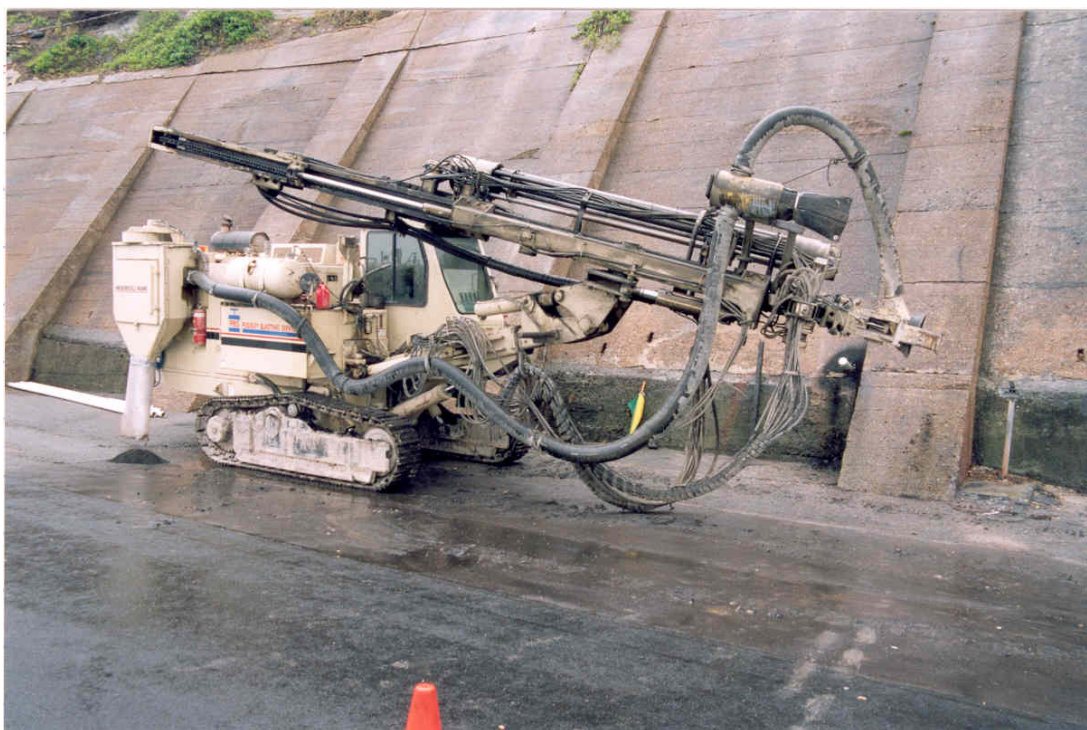
DRIFT 1 – After completion of Drilling

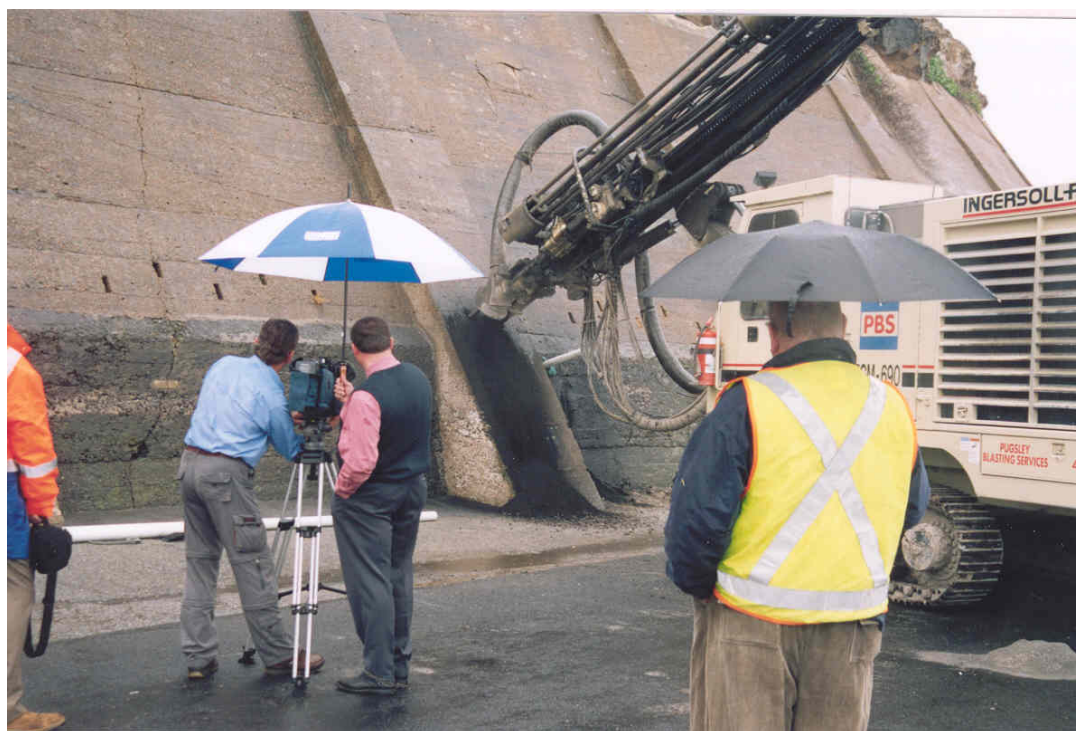
DRIFT 2 – Drilling of Second Borehole (BH3)

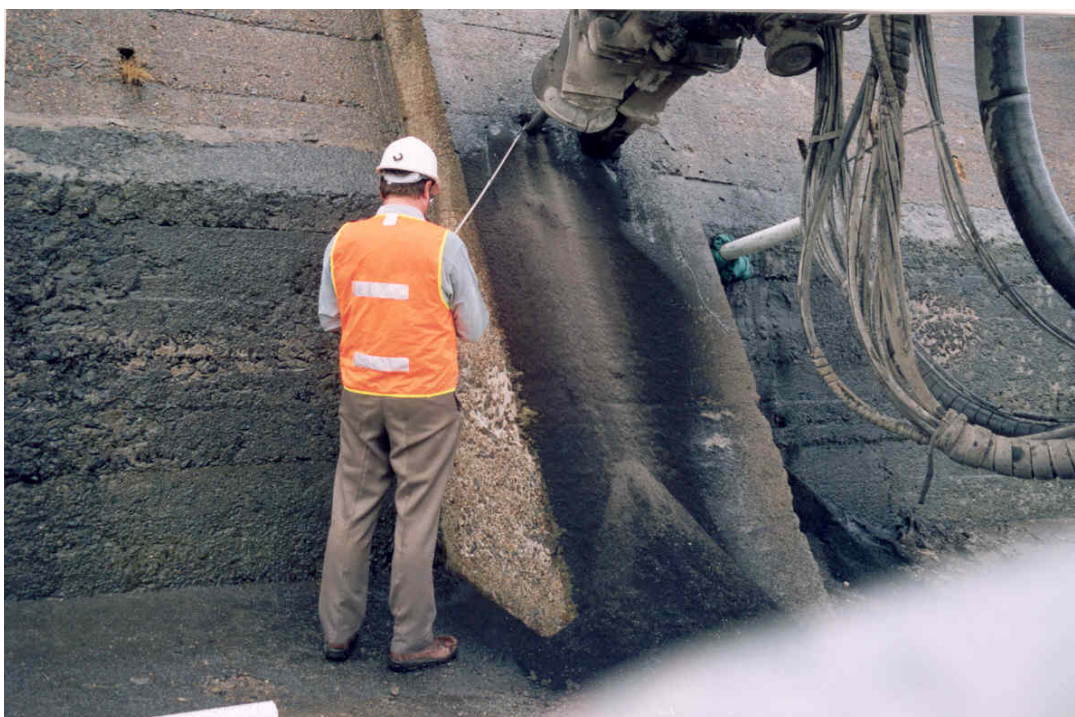
DRIFT 2 – Testing for Explosive Gas in Borehole

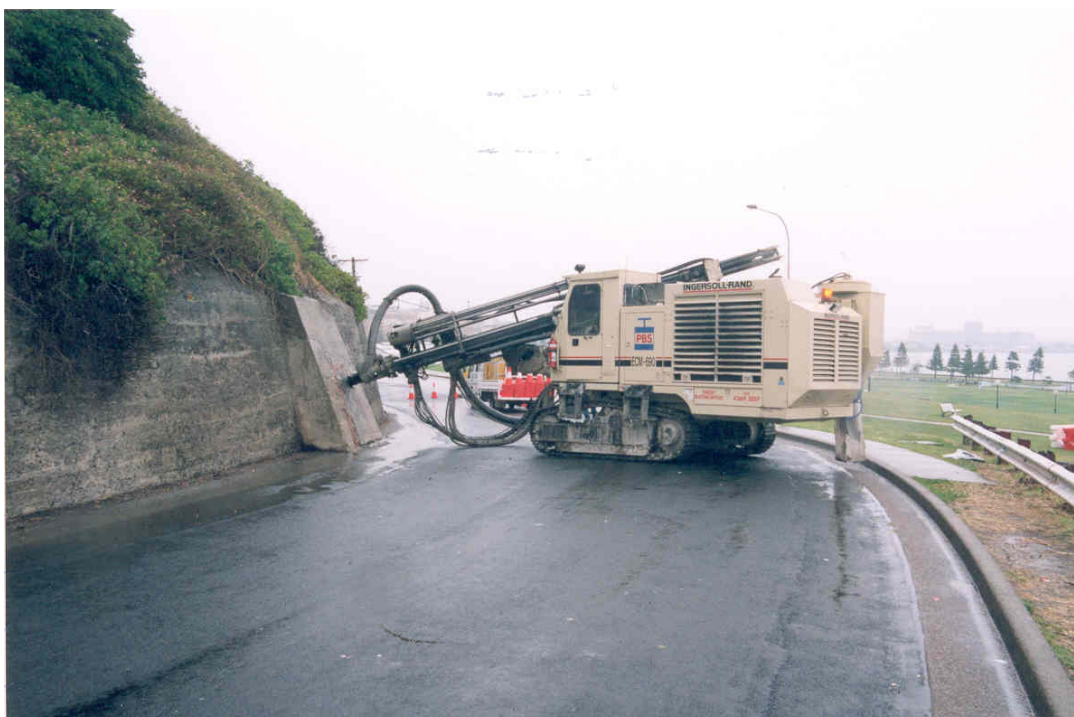
DRIFT 3 – Drilling of Borehole

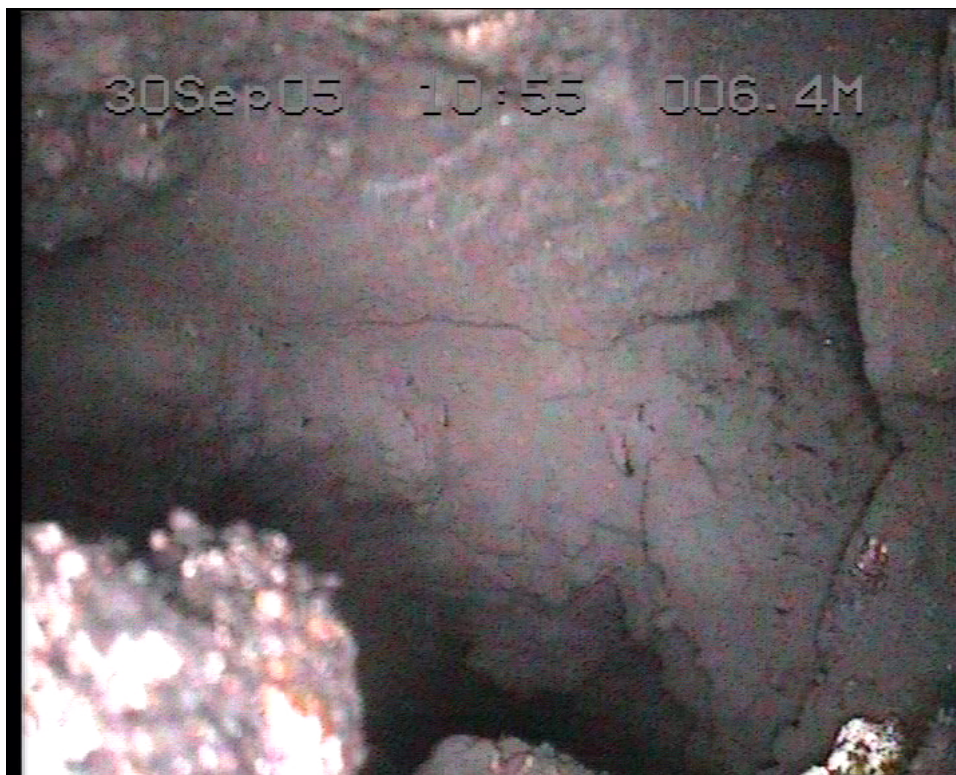
Unfortunately in BH3 the casing was blocked with debris that precluded entry of the camera or light to attempt to better establish the extent of the workings in the area;

DRIFT 2 – Coal Mine working in BH3 as reviewed with CCT Camera

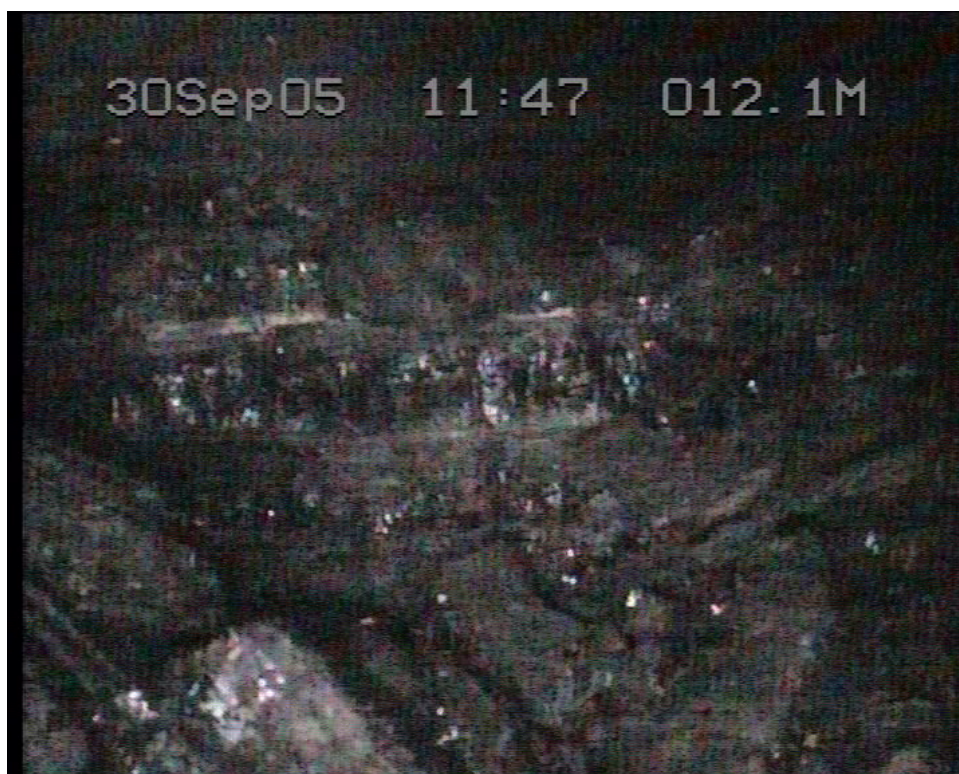
In BH5 the void was 10.4m inside the hill at a low angle (8°) and the void was more extensive and again appeared to extend towards the left. Intact coal with clay seams could be viewed directly ahead of the camera with some intact coal in the roof.

DRIFT 3 – Intact coal in BH 5 as reviewed CCT Camera

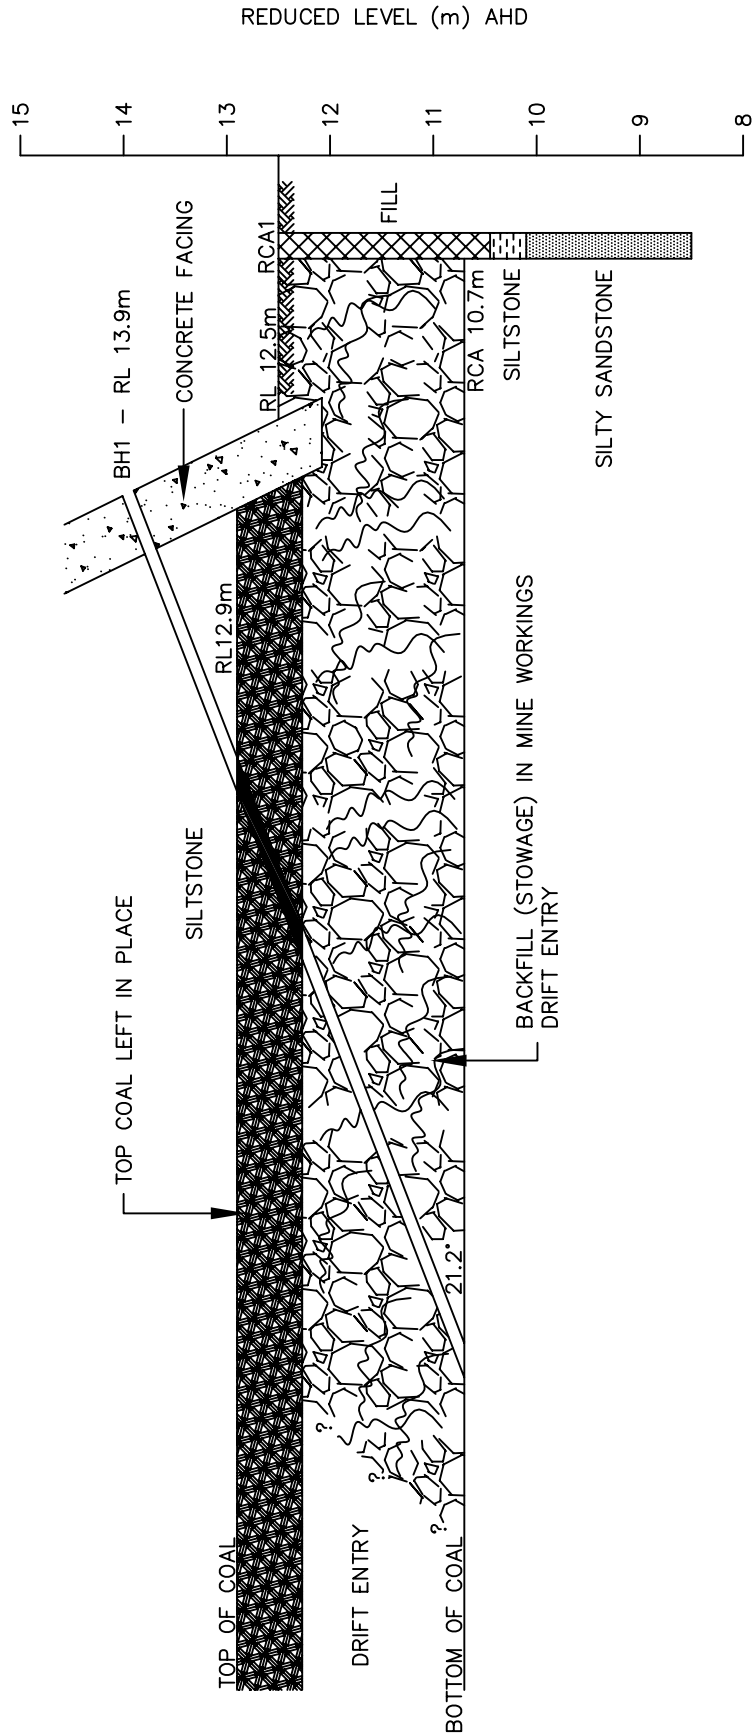
The drill penetrated about 0.5m of concrete, then about 2m of weathered Siltstone before encountering **COAL** that continued for a distance of 4.2m from the entry point;

At 4.2m the drill encountered a **VOID** through which the drilling rods could penetrate without the need for the percussion drilling techniques used for drilling through hard material for a total distance of 8.9m from the surface of the rampart;

The log of the borehole is attached and a section through the boreholes is shown on Figure 1;

The coal seam is essentially horizontal and after correcting for the angle of dip of the BH1 (21°) the void would be about 1.4m high with about 0.6m of coal left in the roof. This agrees with historical and nearby Borehole records that indicate that the coal seam was about 2m high and that only the lower 1.4m was mined. It was reported that the upper 0.6m was inferior coal and was generally not mined;

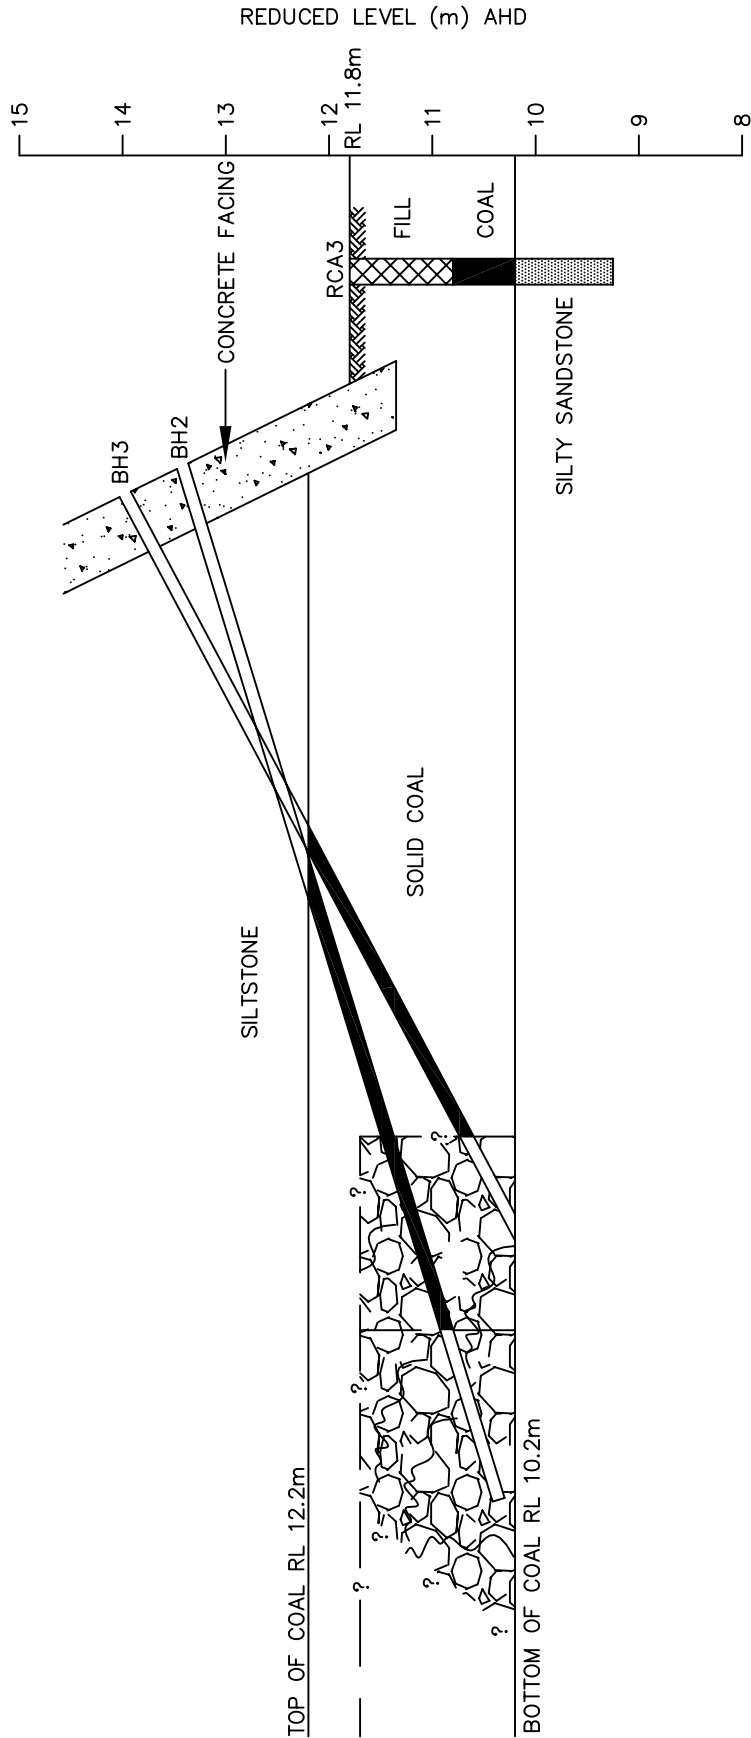
The drilling encountered about 0.5 of concrete before penetrating about 4m of fill and siltstone. Coal was encountered at about 8m from the face and extended to 8.7m where a void was encountered. The void was less than 2m wide before reaching refusal to push from the drilling rig. The void appeared to be partly full of debris. Again the coal seam was about 2m thick with the elevation of the seam being similar to that of the nearby borehole. This is illustrated of Figure 2 attached;

BH3 was drilled at a steeper angle of 28° in an attempt to intersect the void closer to the face. Again a small void was encountered at a similar elevation as at BH2, but closer to the face of the ramparts;

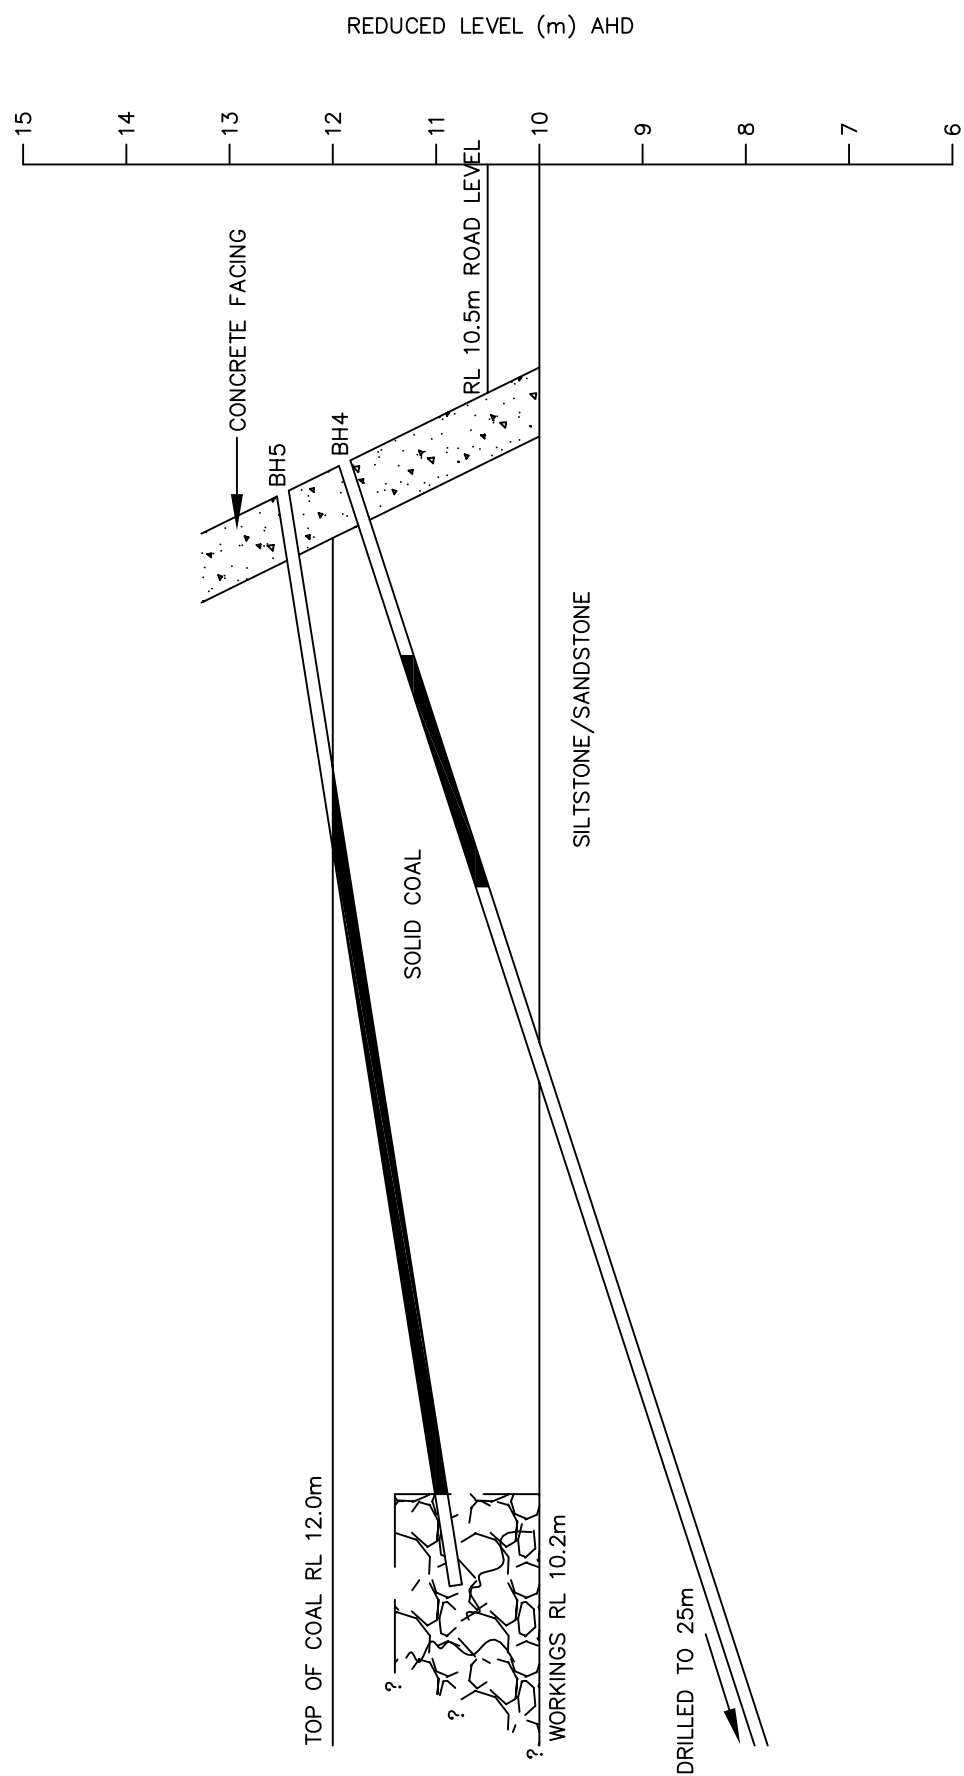
BH4 at Drift 3, the most northerly drift near the roundabout was drilled at an angle of 17°. The borehole encountered a small coal seam, but since some doubt remained as to its correct identification the borehole was continued to a total length of 25m without encountering another coal seam. The borehole had apparently passed through the base of the coal seam;

The coal seam was first encountered at a distance of 3.5m and continued to about 10.4m where a void was encountered apparently about 1m wide. The geometry of these two boreholes is illustrated in Figure 3;
